Final Report on Sabella incident May 2013

This report to the Nelson City Council reviews actions taken on notification of an incursion of the fanworm *Sabella spallanzanii* in Nelson Harbour. Identification has been confirmed but spawning is unlikely to have occurred due to immaturity of the specimens examined and that there appeared to be a single age class of worms on the vessel.

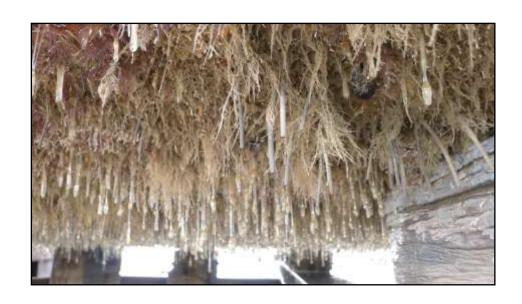
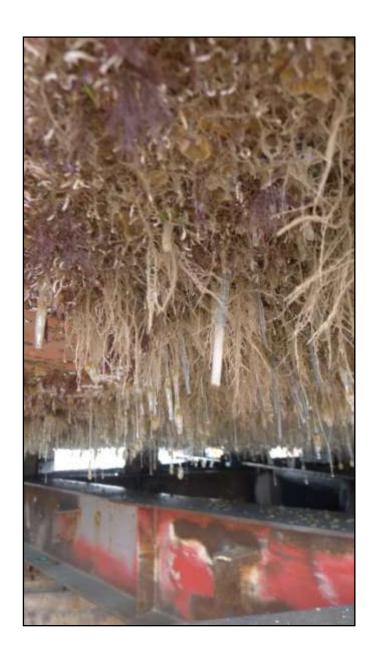
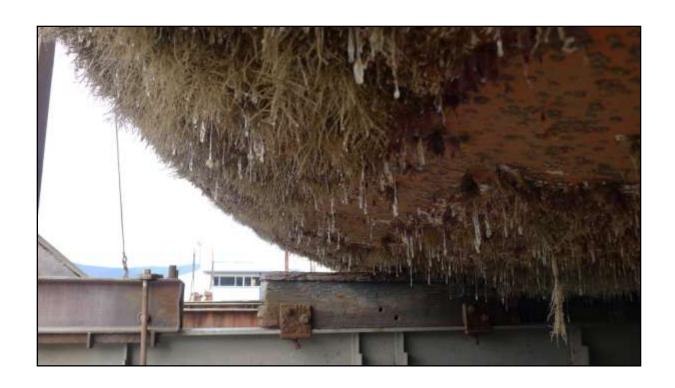
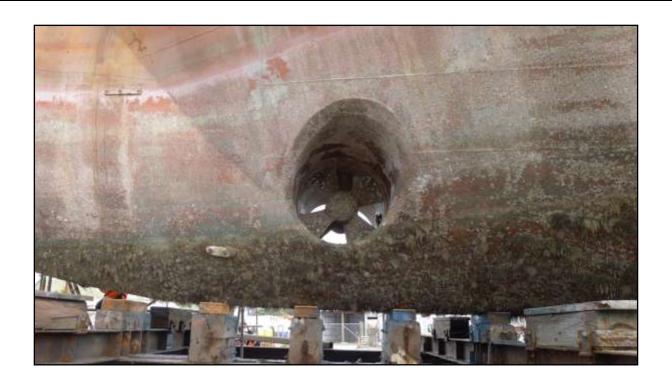
I went down to the slip this morning (Sat), having phoned them and been told that no--one would be working, to find that the Manini was being water blasted. I managed to get onto the slip as Bruce suggested, and collected some worm tubes off the underside of the hull towards the bow, and took some photos. Couldn't get to the stern as they were working there. I've preserved the specimens and will send to MITS on Monday. I had a word with the skipper, who has recently bought the boat - it has been in Auckland for some months prior to arriving in Nelson 3-4 weeks ago, as Bruce indicated. Since arriving in Nelson it has been on the layup berths.

Water blasting began with Nelson City water at 6000psi. All water and material washed to contained sump. Water behind dam with some leakages around seals down slipway into harbour. Sump hand cleaned of debris which was placed in wool sacks for transit to land fill in York valley. All water reaching sump pumped out through plate settlers for discharge to sewer. Sewer goes to Bell's Island with transit time of 15 to 20 days.

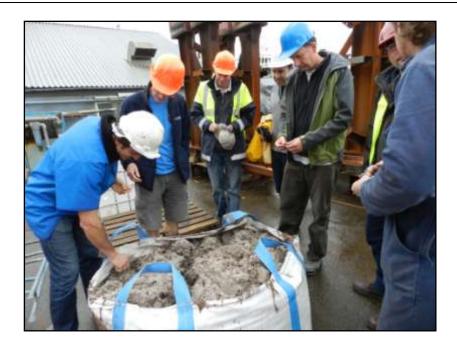
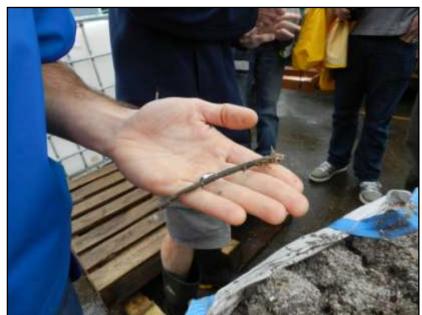
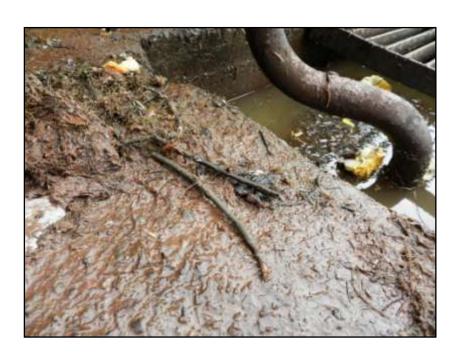
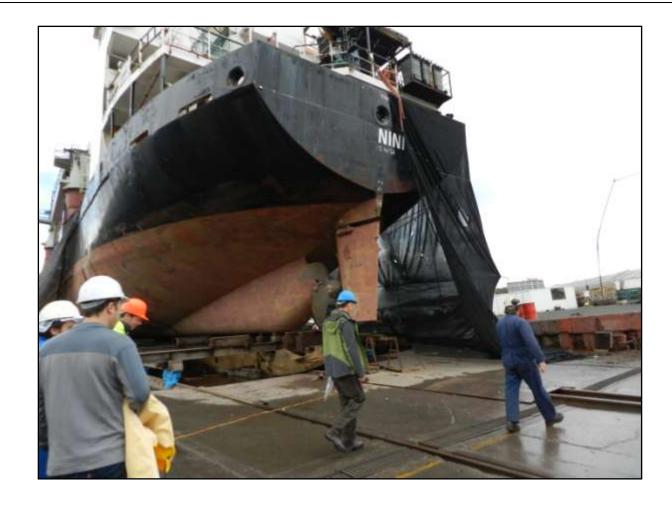
- 8.45 am Rang Caldwell slipway and talked with Andy Wills the supervisor and agreed to meet on site.
- 10.00 am Met on site with Matt Molloy, Barrie Forrest, Grant Hopkins (Cawthron), Don Morrisey and other NIWA and Cawthron staff. Worms inspected by scientists and suggested they were 70% certain they were Sabella. Leathery striated casing were positive indicators but all worms were dead so crown could not be seen. The tubes seen were just over 100mm long and Andy Wills said the longest he saw removed were 120mm. Vessel reportedly last anti-fouled February 2012 in Papua New Guinea. Andy Wills also reported that he had enquiry to slip the Daniel Solander which is also in Auckland and likely fouled with fanworm. He will let us know if that will take place.
