# Regional Recreational Vessel Hull Fouling Survey and Boater Questionnaire

Barrie Forrest

**Technical Report 2016/01**

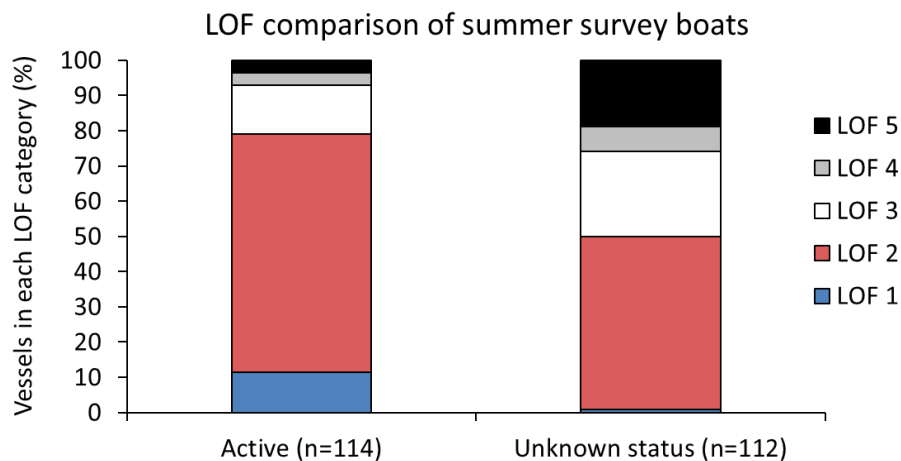
Boats that were in active use as defined above were clearly less fouled than those whose activity status was unknown (Figure 4). Approximately 8% of active boats were heavily-fouled, with LOF  $\geq 4$ , whereas this figure was 29% for the remaining boats of unknown activity status. These data suggest that boats in active use are more well-maintained than boats that may otherwise be sitting idle (e.g. at moorings or marina berths). This finding is consistent with the expectation that many boaters clean and antifoul their vessels in the few months leading up to planned periods of summer activity (see also Section 3.3).

**Figure 4.** Proportion of vessels in each LOF category, comparing boats from the summer 2015/16 survey classified as being in active use with boats whose activity status was unknown. Bracketed numbers indicate the number of vessels in each category.
