Regional Recreational Vessel Fouling and Marine Pest Survey 2017/18

Top of the South Marine Biosecurity Partnership

Barrie Forrest

Technical Report 2018/01

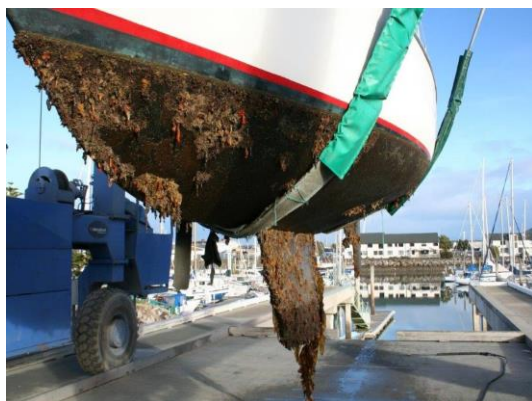
Recreational vessels often get heavily fouled

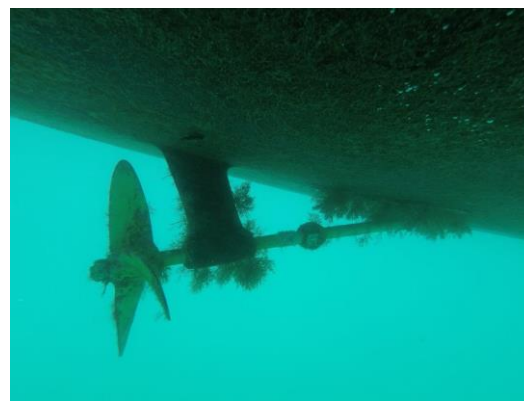
Some vessels have a hull that appears clean, but which is fouled in niche areas below the water-line

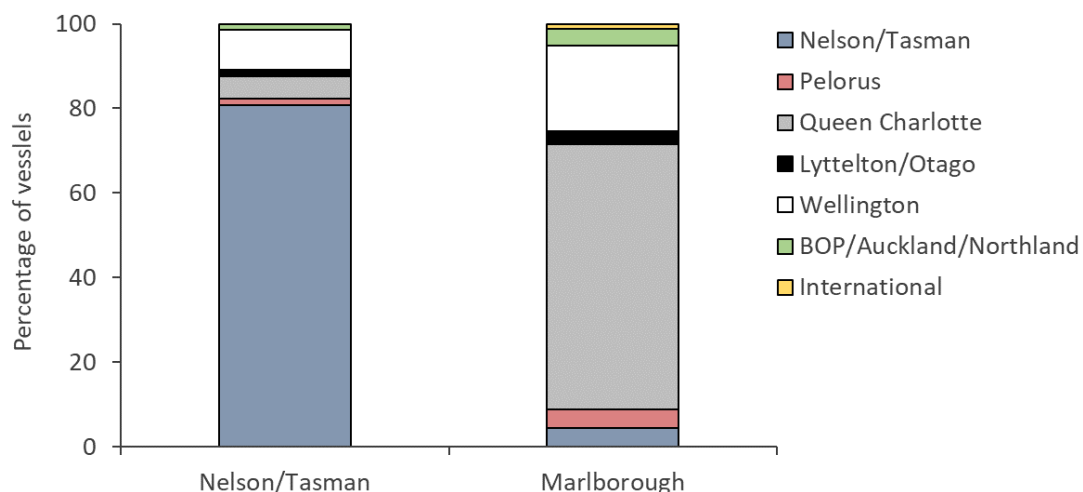
Figure 4. Proportion of vessels active within either Nelson/Tasman or Marlborough that came from different locations within and outside the TOS. Summary derived from the survey responses of 231 boaters across the two main areas. BOP = Bay of Plenty

Of the 544 vessels, 232 had people of board, although not all knew the history of the vessel (e.g. some were hire boats). The home port was determined for 231 of the vessels. Approximately 23% were from locations outside the TOS, of which only two were of international origin (Table 4). Of the New Zealand boats originating outside the TOS, 39 (17% of total vessels) came from Wellington; mainly from Mana Marina. Only six vessels were from Auckland and Northland localities where the fanworm is well established; however, no fanworm was found on these boats (see Section 0).

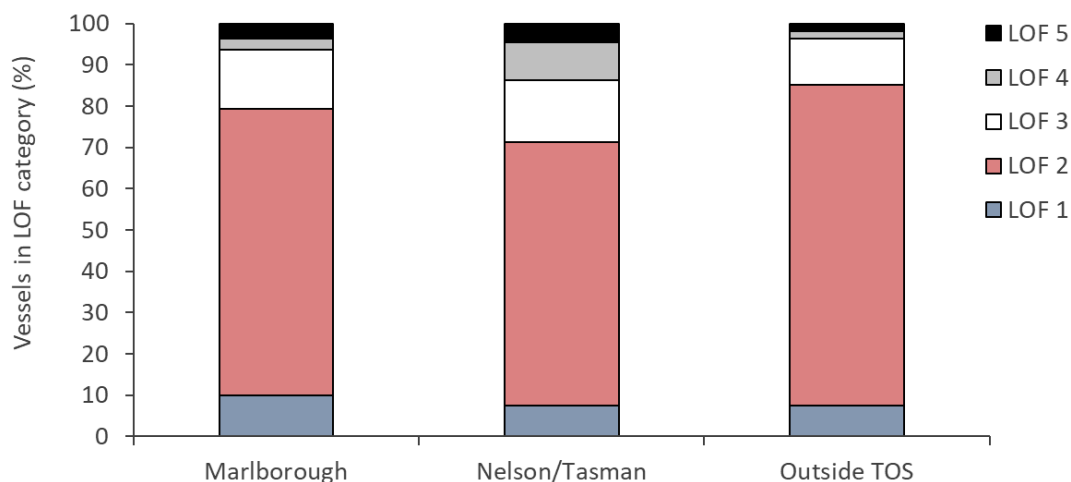
Figure 7. Proportion of vessels in each LOF category, comparing boats whose home port was from either Marlborough (n=111), Nelson/Tasman (n=66) or outside the TOS (n=54).

When hull fouling was considered in relation to the home region of the vessels (see Table 2), it is apparent that Nelson/Tasman vessels (which originated mainly from Nelson marina) were more heavily-fouled than boats from anywhere else (Figure 7). Around 14% of Nelson/Tasman boats were LOF ≥ 4 , whereas for Marlborough this figure was 6%, and was 4% for vessels originating from outside the TOS. This finding is consistent with earlier TOS studies showing that boats in Nelson marina had higher LOF scores than boats from Waikawa (Forrest 2014).

Consistent with the 2016/17 data, most Wellington boats were well-maintained and had only light fouling (LOF 2). Boaters from this region were reasonably aware of marine biosecurity issues; the TOS Coordination Team has been working with Wellington marina managers to encourage vessel maintenance before departure for the TOS. The most heavily-fouled out-of-region vessel originated from the Bay of Islands where the fanworm is widespread. This boat was very-heavily fouled (LOF 5) and was anchored in Chance Bay in inner Pelorus Sound, directly adjacent to mussel farms in Nydia Bay (see Figure 3). Although no fanworm was detected, this situation illustrates how easily marine pests could be transported directly to the heart of the country's most significant aquaculture region.

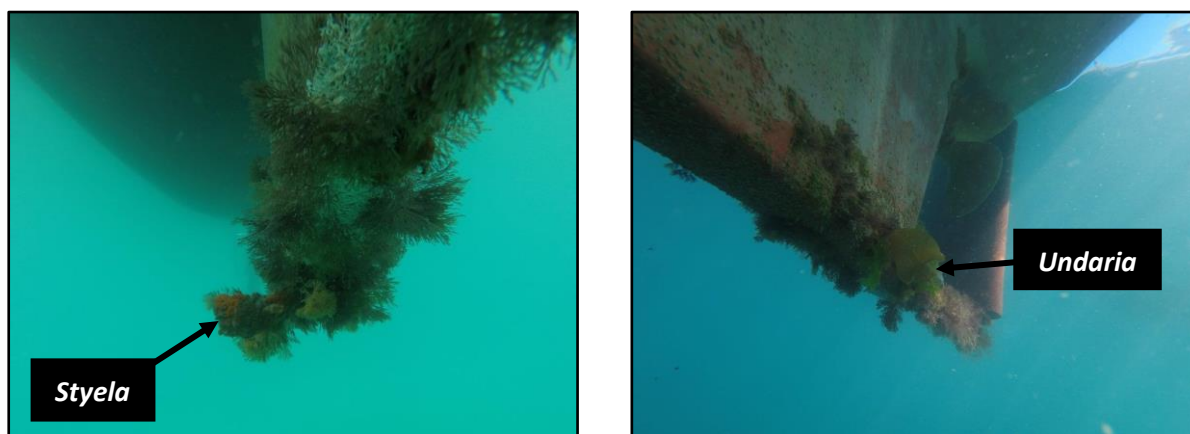
Among eight active vessels carrying *Styela*, all were yachts, with the sea squirt in most cases on the bottom of the keel. Hence, as with previous TOS surveys, as highlighted by overseas studies (Clarke Murray et al. 2013), the 2017/18 work highlights the need for better maintenance practices for this key niche area. Six of these vessels originated from Nelson marina, one from Waikawa marina and one from Auckland. Interestingly, the Auckland vessel had been dived in Auckland and apparently “certified” as pest-free.

The bottom of the keel, especially in the case of yachts, can be heavily-fouled even when the main hull is clean and well-antifouled

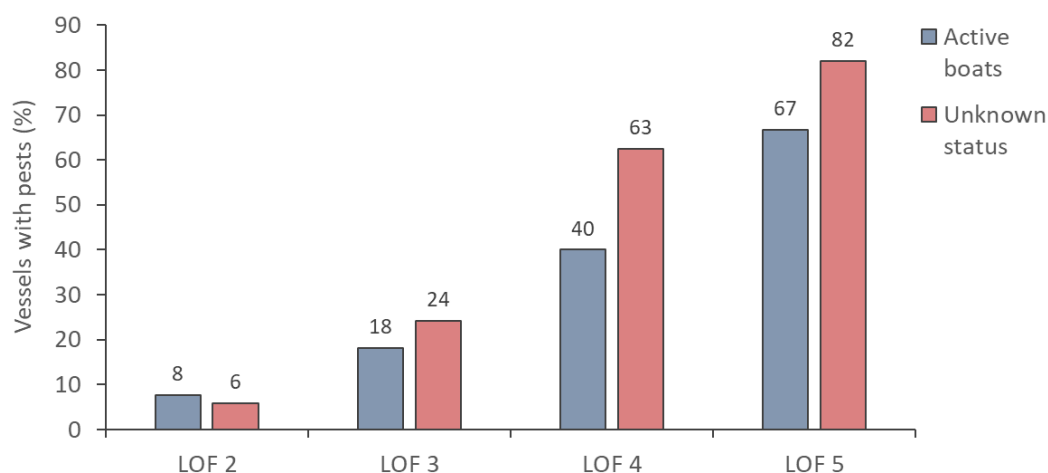
Figure 10 highlights the clear trend previously reported, that as LOF increases, so does the proportion of vessels carrying marine pests. Pests were notably less prevalent on active vessels (13% infected), than vessels whose activity status was unknown (29% infected). Active vessels also had a lower prevalence of pests in the higher LOF (3-5) categories. Pests were slightly more common on sail boats (24% infected) than power boats (19% infected). These differences are consistent with research findings that marine pests may be physically dislodged or damaged on active vessels, especially those whose speeds exceed c. 10 knots (yachts would typically travel

at c. 7-8 knots). For active vessels, it is probably also the case that maintenance is often conducted before planned voyages (see next section).

Figure 10 highlights that vessels with even light fouling (LOF 2) can harbour marine pests; for example, c. 7% of LOF 2 vessels had pests (21 of 306 LOF 2 vessels). As noted above, this situation arose due to the occurrence of *Styela* and other pests on the bottom of the keel, or in other niche areas (e.g. rudder, pipe outlets, trim tabs) that lacked an effective antifouling coating.

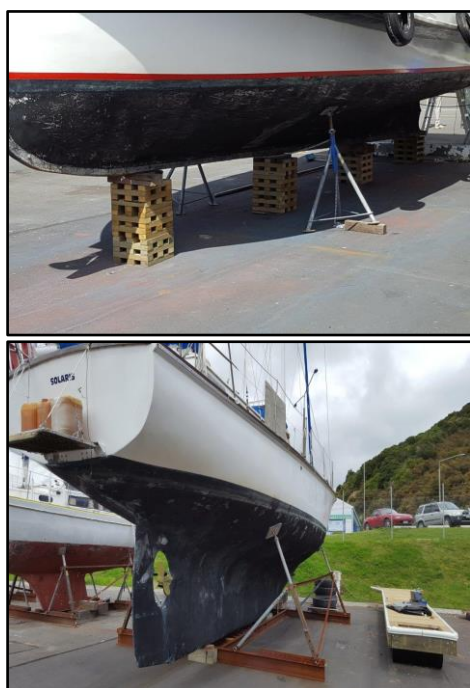
The bottom of vessel keels is difficult to antifoul, and is a problem area for pests

The TOS Coordination Team has been investigating solutions for improving effective coating application in such niche areas. In the case of vessel keels, a key challenge is that the bottom of the keel can be difficult to access while the boat is on hard-stand. While it is technically feasible to have the boat lifted (e.g. by travel-lift) so the keel can be coated, the cost increases and the lift itself may be unavailable. Many boaters therefore paint the keel bottom when their vessel is lifted off the hard-stand for placement back into the water. However, due to insufficient drying time it can be expected that most of this paint would soon wash off. Hence keel antifouling will be ineffective, and pulses of antifouling contaminants like copper will be released.
