Regional recreational vessel fouling and marine pest surveys: synthesis of data 2016-2019

Prepared for
Top of the South Marine Biosecurity Partnership
June 2019

Salt Ecology
Report 017

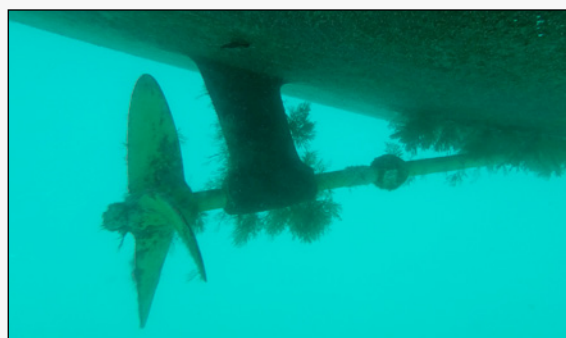
Some boats have a hull that appears clean, but can be fouled in 'niche' areas below the water-line.

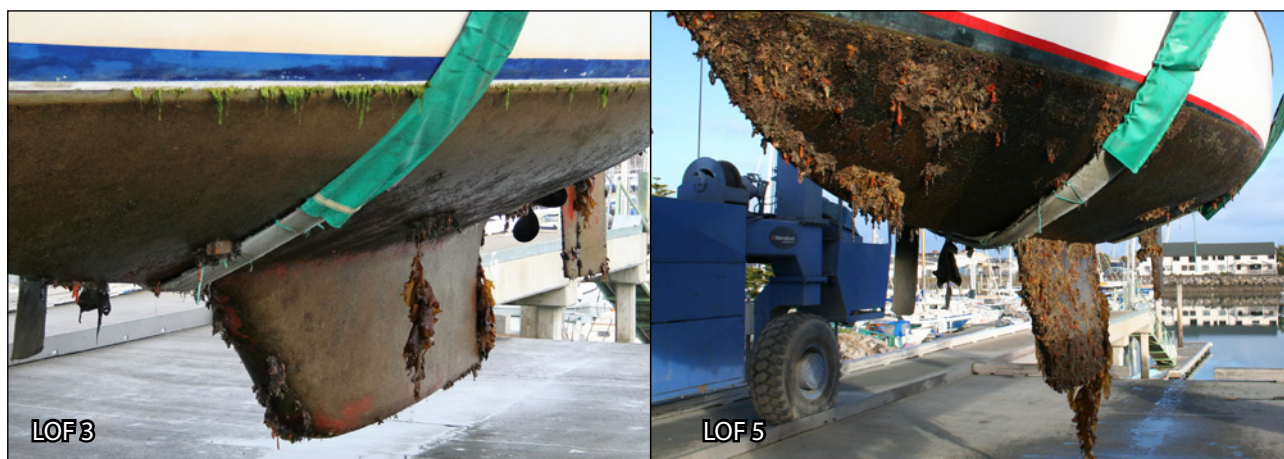
Fig. 2. Vessel level of fouling (LOF). Examples of LOF 3 and LOF 5.

Each vessel surveyed in-water was assigned an overall 'level of fouling' (LOF) score based on categories described by Floerl et al. (2005) and shown in Table 2 and Fig. 2. The LOF approach has been used in hull fouling studies in the TOS as well as elsewhere in New Zealand (e.g. Lacoursière-Roussel et al. 2012; Brine et al. 2013; Forrest 2016, 2017a, 2018). It is evident from such studies that the likelihood of marine pests being present amongst vessel biofouling increases with increasing LOF.

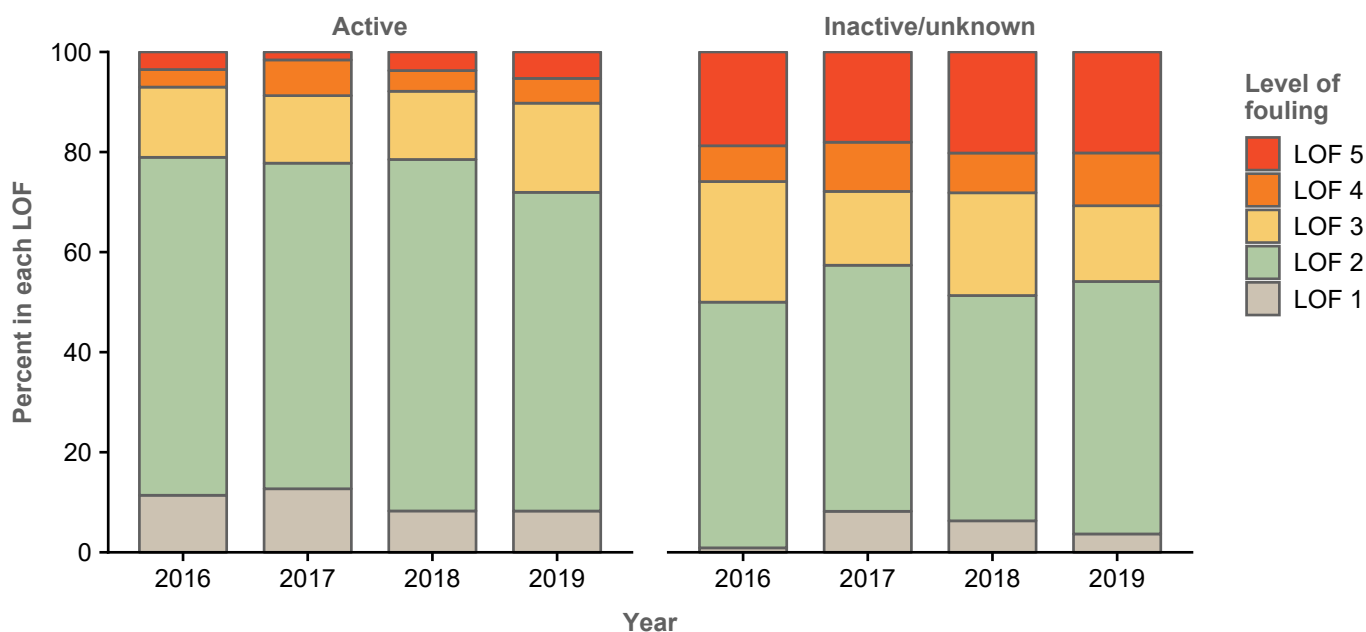
Fig. 5. Regional patterns in vessel LOF. a) Proportion of vessels in each LOF category comparing boats classified as being in active use vs inactive/unknown (n = 61 to 303), and b) Regional distribution of active boats for each of the LOF scoring categories.

Fig. 5a shows LOF scores over regions and surveys, comparing active boats with those whose activity status was classified as inactive/unknown, with Fig. 5b illustrating the regional distribution of active boats with respect to each of the five LOF categories.

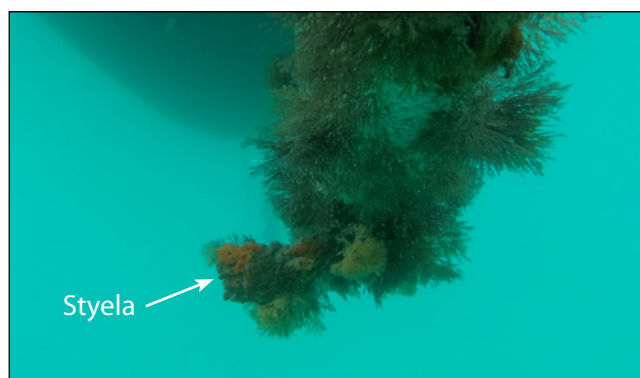
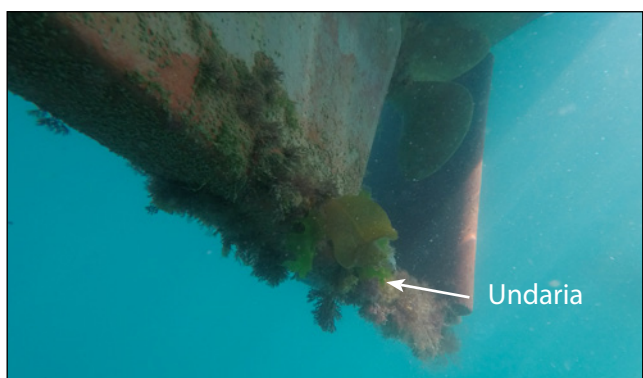
The bottom of the keel, especially in the case of yachts, can be heavily fouled even when the main hull is clean and well anti-fouled.

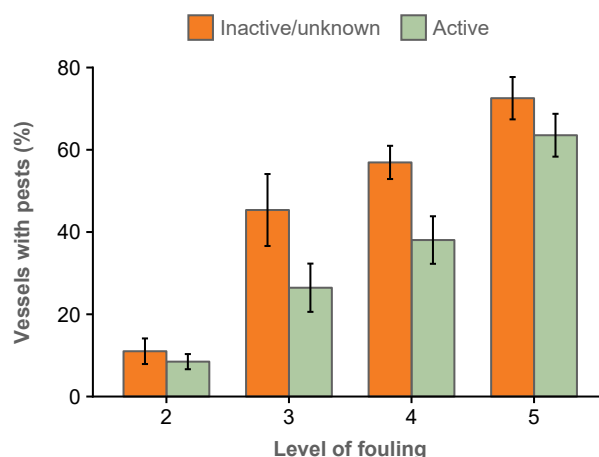
Fig. 11. Mean percentage (\pm SE, n=4 surveys) of recreational boats with any one of the designated pests from Table 2 present in each LOF category, with vessels categorised as being in active use or inactive/unknown in terms of their activity status. By definition, no visible pests can be present at LOF 1 (i.e. no macrofouling is present at LOF 1, see Table 1). Samples sizes for calculating of means ranged from 31 to 102 observations.

Of relevance from Fig. 11 is that even vessels with 'light' fouling (LOF 2) can harbour marine pests. In all cases this reflects niche area fouling by pests, usually on the bottom of the keel as noted above. Furthermore, although only 8% of active LOF 2 vessels had pests compared with 64% of active LOF 5 vessels, in terms of total numbers, there were 38 LOF 2 vessels with pests present, compared with 20 LOF 5 vessels.

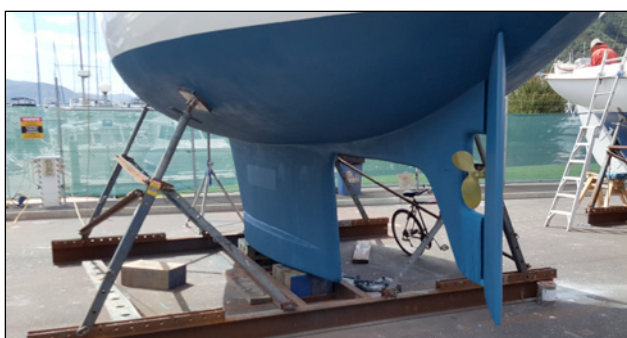
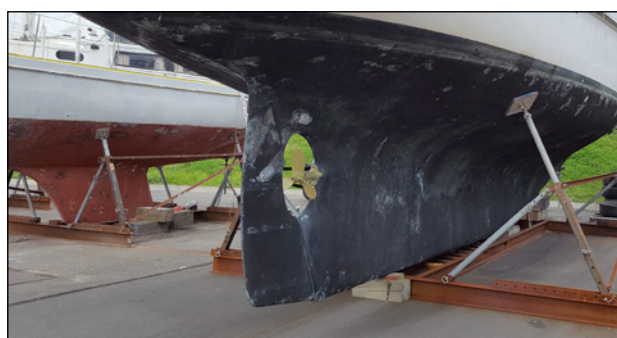
The bottom of vessel keels is difficult to anti-foul, and is a problem area for pests.
